Property Inspection Report

Happy Family

1120 Best Life
Santa Fe, NM
June 12, 2021

Perry Home Inspections

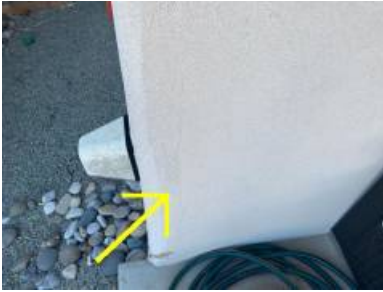
The stucco has hairline cracks that are normal. If any crack opening become 1/8 inch or larger, it is recommended to have the crack repaired.

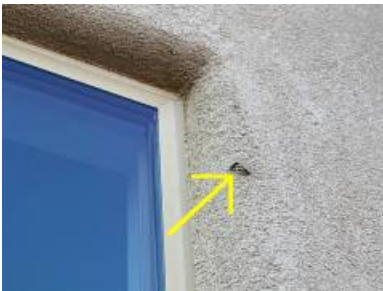
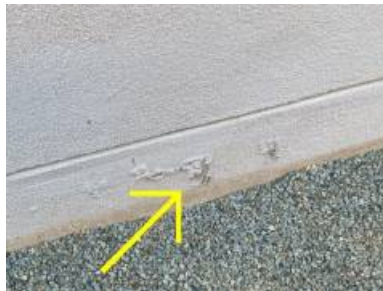
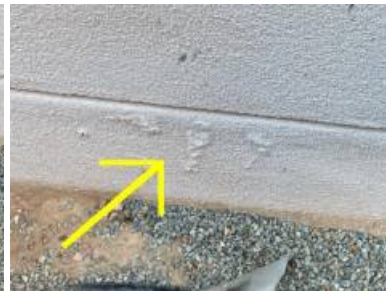
The stucco is peeling at the hallway bathroom east wall and living room lower east wall. Recommend having the stucco evaluated for repair.

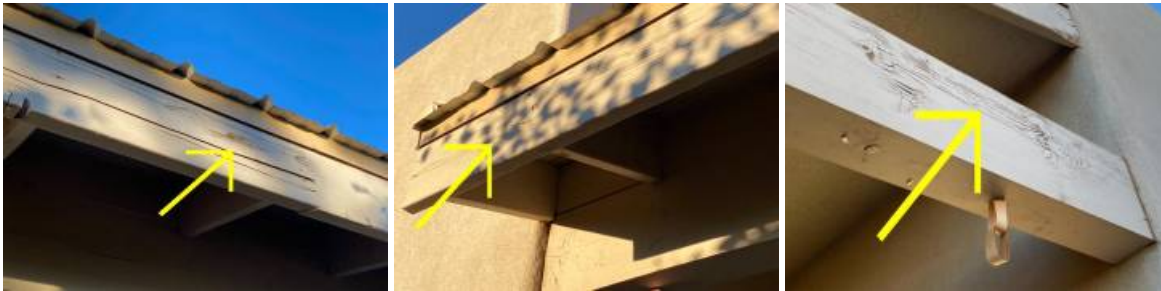
The roof fascia is showing signs of wear to the sealer/paint at the south portal/porch. Wood that is not properly sealed can deteriorate over time. Recommend having the wood sealed to prevent deterioration of the fascia trim.

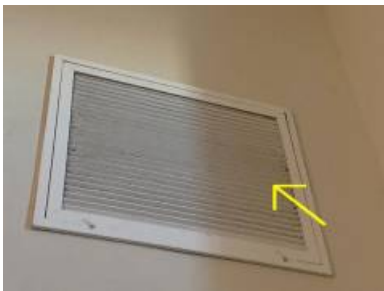
The ducting system is design to have an air filter installed at the return register(s). The filter is dirty and in need of replacement. Recommend having the filter replaced.

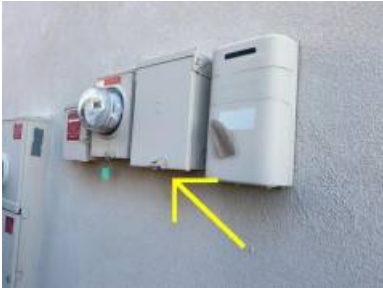
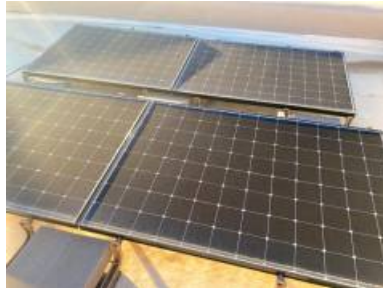
The home is equipped with a solar electrical system. The system is a roof mount installation. The testing of this type of system is beyond the scope of a home inspection and was not operated.
